Re: Nelson v Forest River

Exponent Project Number: 2409104.000

Pursuant to your request, Exponent has reviewed the Plaintiff's Expert reports by Dr. Folkers Rojas and Dr. Matthew Angle regarding two vehicles purchased by Mr. Jay Nelson, the 2019 Forest River Palomino Puma 5th wheel, Model: PUF295BHSS, (VIN: 4X4FPUF28KP079346) and the 2020 Puma PUF29BHSS (VIN: 4X4FPUF22LP084415). Both reports provided opinions regarding Forest River with little regard for the circumstances of the two incidents on the two vehicles owned by Mr. Nelson. This report has been prepared to discuss the Plaintiff's expert reports.

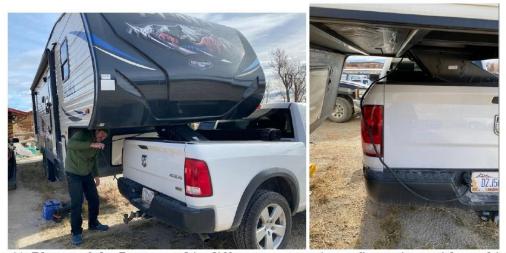
Figure 3: 7-Way Cord Wrapped Around the Wrong Side of the Truck

1.21. Dr. Rojas on page 81 with the assistance of Dr. Angle deceptively show the 7-way cord routed over the side panel of the truck bed on the side closest to the 5th wheel trailer. This is not how the cord was routed during the Nelson incident; however, it does demonstrate that the 7-way cord can wrap around outside the truck bed side panel, as shown in Figure 3 (which is Figure 41 in the Rojas report).

Figure 41. Photos of the 7-way cord in different geometric configurations with a vehicle

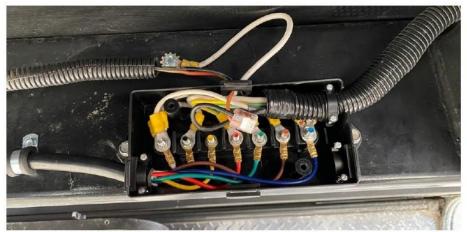
Figure 4: Proposed Configuration

1.22. Dr. Rojas on page 82, proposed an alternative design, as shown in Figure 4 (which is Figure 42 in the Rojas report).

Figure 42. Upgrade to the 2019 Puma wiring with a plastic junction box

- 1.23. The force applied on the 7-way cord would likely produce similar results and damage in the proposed plastic junction box with the wire pulling out.
